# CORROSION IN SOLAR PV GROUNDING AND BONDING

Paul Kovalov, P.E.  
Burndy, LLC  
47 E. Industrial Park Drive  
Manchester, NH 03109  
pkovalov@burndy.com

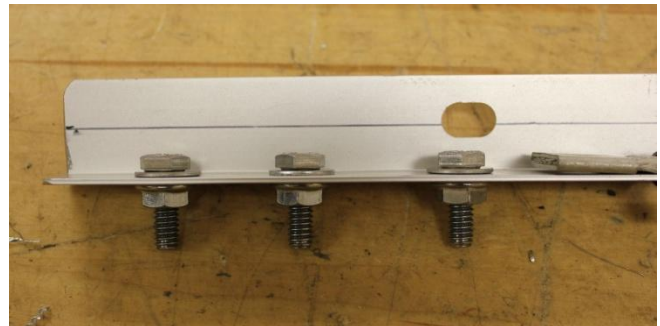
Fig. 1: Anodized aluminum angle with stainless hardware

Figures 1, 3 and 4 show some common combinations of materials and devices used in the solar PV industry. Figure 1 shows 1/4"-20 bolts installed onto a 1.6 mm (0.063 in) thick anodized aluminum angle. The threaded hardware was tightened to 8.1 N-m (6 ft-lbs) of torque, with anti-seize lubricant applied to the threads. Figure 2 shows the flat washer installed under the head of the bolt, and the 1/4"-20 serrated flange nut that secures the assembly to the angle. All hardware shown is 18-8 (304) stainless steel, and is commonly passivated during the manufacturing process. It

is important to note that the passive oxide layer may be disturbed or removed during manufacturing or assembly. This combination of stainless hardware and anodized aluminum is extremely common in PV arrays.

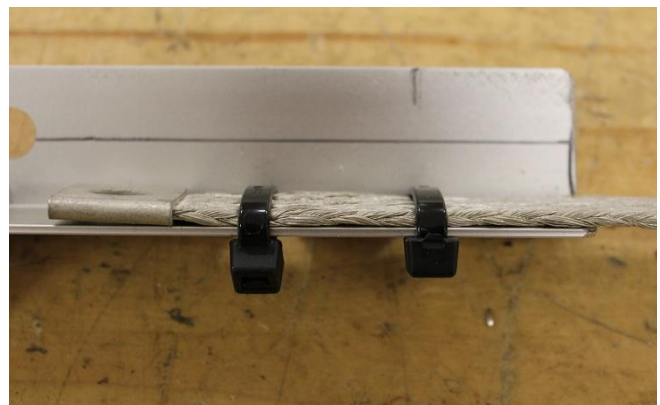
Fig. 3: Anodized aluminum angle with tin-plated copper braid

Figures 3 and 4 show a tin-plated copper braid attached to and in contact with anodized aluminum angles. Figure 4 shows where anodizing has been removed from one of the aluminum angles. Both examples represent common applications seen in grounding and bonding device assemblies.

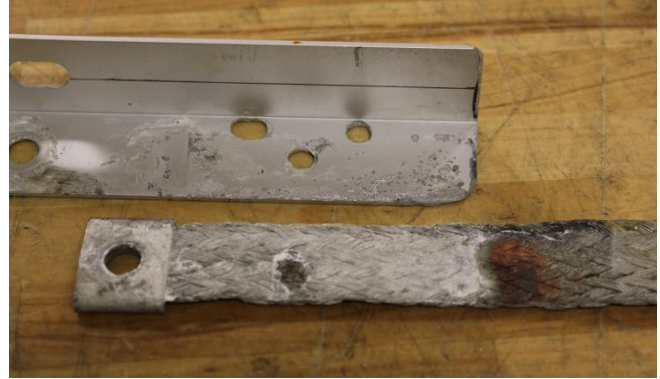
Fig. 6: Corrosion at unprotected edge of aluminum angle

Figure 6 illustrates the kind of damage that can occur when tin-plated copper comes into contact with an un-protected aluminum edge. Tin and copper have galvanic potentials that are comparable, as seen in Figure 1.

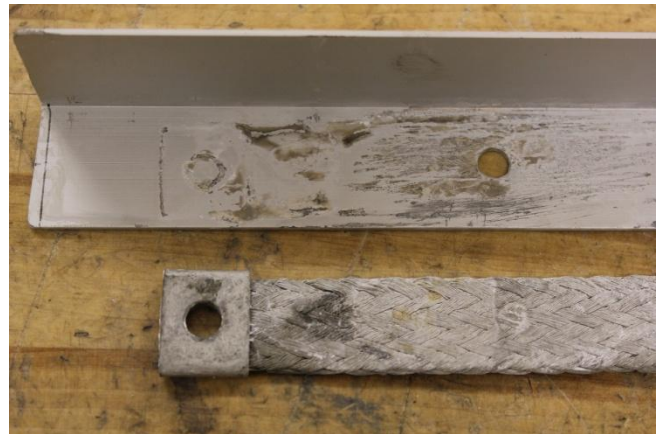
Fig. 7: Corrosion under alternate braid configuration

When compared with Figure 6, Figure 7 shows substantially less galvanic action on the tin plating. Damage to the exposed aluminum under the braid is comparable in severity to the damage and discoloration of the intact anodizing. A notable similarity is the increased rate of corrosion at edges and corners, due to additional surface area available for the reaction.
