## EVALUATION OF A PROTOTYPE SOLAR AWNING

A prototype solar awning has been designed and installed on a University of Oregon campus building. The solar awning is composed of a light shelf with photovoltaic modules attached tilted 20° to the south. An interior light shelf and LED lights have been installed along with monitoring equipment to evaluate the total amount of energy produced by the system and saved by reducing the heat load of the building. The system has been extensively monitored and the analysis of this system will be used to evaluate the economics of solar awnings on campus buildings across the university system.

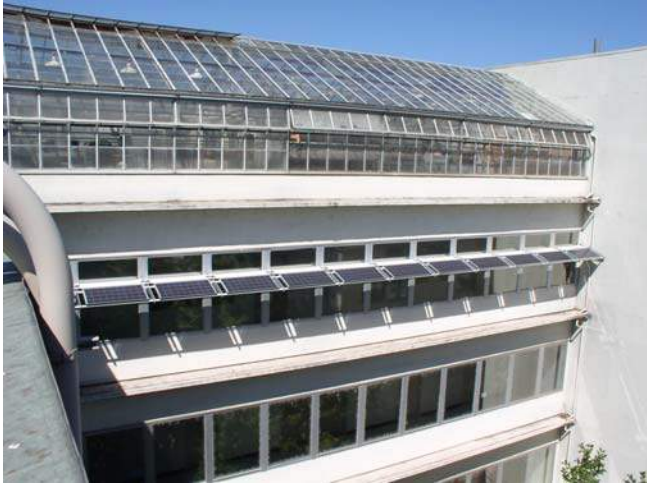
Fig. 1: Solar awning on the third floor of Pacific Hall. The modules are separated into two strings of six to minimize the shading problem on the whole system. The hallway on the second floor will be used as a control.

The prototype solar awning was located outside the third floor of a connecting bridge between two buildings. This connecting three-storey bridge building has a hallway with large windows on the south side and offices on the north side of the hallway (Fig. 1). The hallway often experiences excessive heat in the summer even with tinted film placed on the windows and air conditioning in adjacent wings of the building. The hallway on the floor below the awning has the exact physical attributes of the experimental third floor and will serve as a control when the awning cooling capacity system is tested this coming summer. The solar awning consists of 12 Sharp 80 Watt NE 80EJEA solar modules mounted in two strings of 6 modules each. Each string is

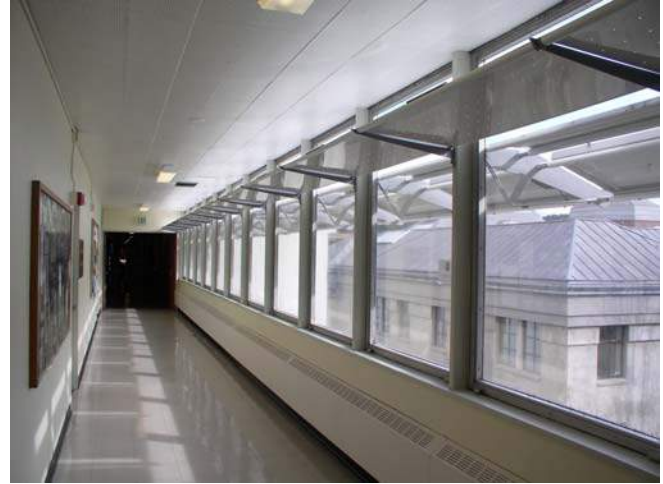
Fig. 2: Light shelf inside the hallway reflects light to the ceiling and spreads the daylight further into the building. LED lighting can be seen on the outer edge of the light shelf. Florescent lighting on the ceiling will be removed when the LED lighting becomes operational.

The inside edge of the interior light shelf is constructed so that the wires for the LED lighting can run along the edge of the light shelf (Fig. 2). The LED lighting will replace the florescent tubes that currently illuminate the hallway. Daylighting controls will be included in the circuit for the LED lighting to further minimize the use of electricity and to help designers and facility managers gain experience with daylighting controls and LED lighting.

A unique feature of this solar awning is the addition of a light shelf. The light shelf produces an interesting pattern of light in the hall (Fig. 2). Before the solar awning was installed the walls were painted pastel yellow with a 1.2 m (4 ft) high blue trim and the ceilings were off white for an average light reflectance of 40% and 70% respectively. To increase the indoor reflectance ratios for maximum daylighting and a reduction in glare index ratio of the windows to walls, a light yellow and pale green was used around the frames to increase the hallway’s reflectance to 75%. The ceiling tiles were painted white to increase the reflectance to 90%. The new paint certainly brightened the hallway and increased the daylight efficacy. When the solar awning was installed, the lighting level did increase because of the light self, but the glare was reduced because the awning blocked the direct sunlight at eye level.

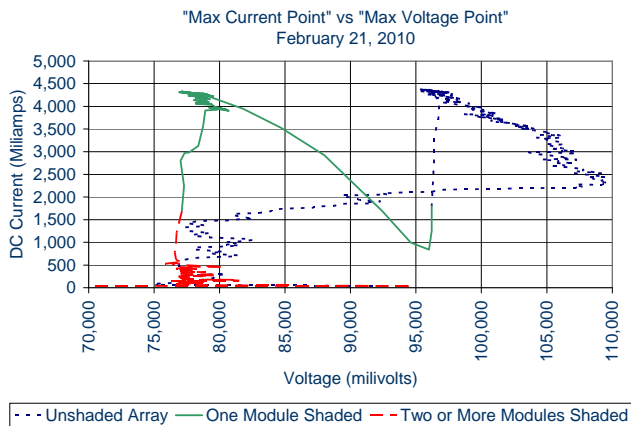
Fig. 10: Plot of DC current and voltage on a clear day when 0, 1, and 2 or more modules are shaded. The max power point tracker operates in the 77 to 120 volt range.

When one module is bypassed, the performance drops by about 17% because 1 of the 6 modules is not contributing to the output. The max point tracker shifts the operating DC voltage from 96 to 77 volts (Fig. 10). When two modules are shaded and bypassed, one would a reduction in max power point voltage to be in the mid-60 volt range and another 17% drop in output. However, the production of the array drops precipitously. The SMA 700 inverter has a max power point range of 77 to 120 volts in the mode of operation chosen for this array. It appears as if the max power point tracker starts to drop the current downward to keep within its voltage specifications and as it does so, the current approaches that of the shaded arrays. With the lower

This is shown in Figures 8, 9 and 10 when the second panel is shaded at around 14:00 and the DC voltage is maintained at about 77 volts. When the third, fourth, and other panels are shaded there is little change as the PV system is already operating as if the whole array was shaded (Fig. 4).

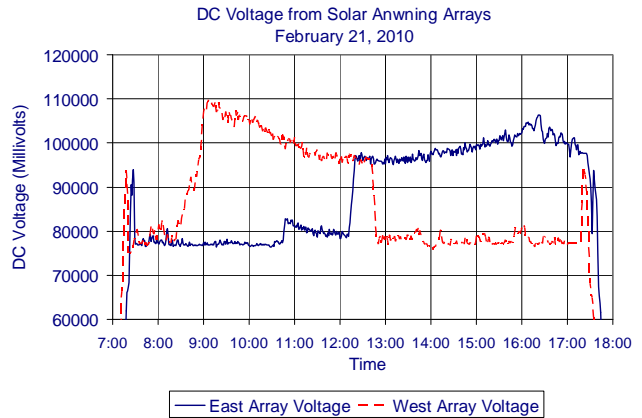
Fig. 9: DC voltage for the east and west arrays.

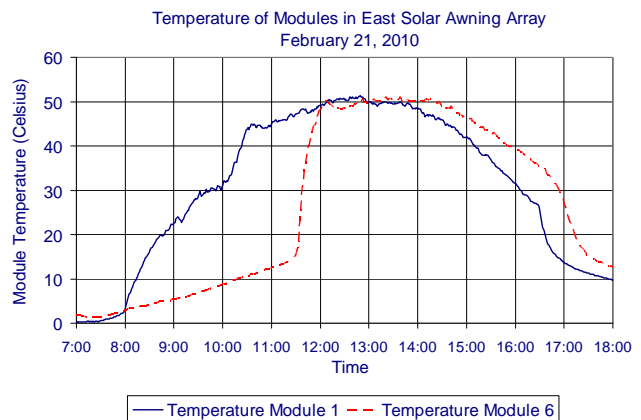
Fig. 11: Effect of shading on PV module temperature. Modules 6 is shaded until 11:30 and while module 1 is free of shade by 8:00 am.

Shading of the modules also affects their temperature as shown in Fig. 11. As expected, modules in direct sunlight heat up faster than those in the shade. The two temperature measurements were taken on the back of the first and sixth module of the east array. Module 6 is located in the east wall and therefore has poor circulation while also receiving reflected light from the east wall. This might result in higher temperatures observed for module 6 in the afternoon after 14:00.

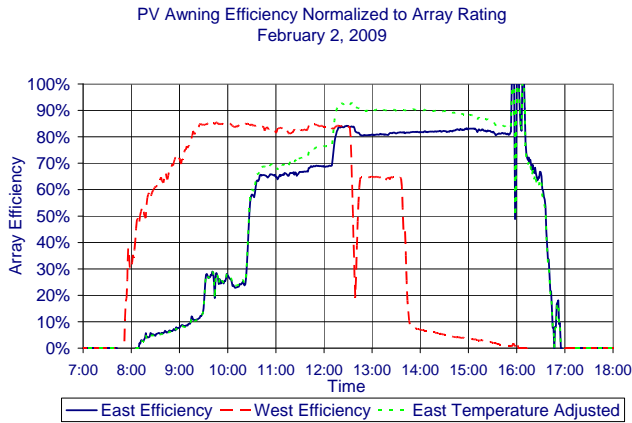
Fig. 12: February 2009—PV AC Output divided by system DC rating. The dotted line is the normalized ratio adjusted for a temperature of 25 Celsius.

A good method for comparing the system performance is to divide the AC output by the incident energy and normalizing the output by dividing by the DC rating of the array. This normalized performance ratio is show in Figs. 12-13.

The correction was only made for the East array because the temperature strips were attached to the back of the modules on the east side. When the solar awning was first installed, the normalized temperature adjusted PV performance was about 90% (Fig. 12). Notice that normalized array efficiency, normalized to a constant temperature, is nearly constant from 13:00 to nearly 15:00 while plot for array efficiency without the temperature normalization increases. As expected, PV efficiency increases as module temperature decreases and when comparing PV efficiency it is important to specify the temperature or normalize it to a reference temperature.

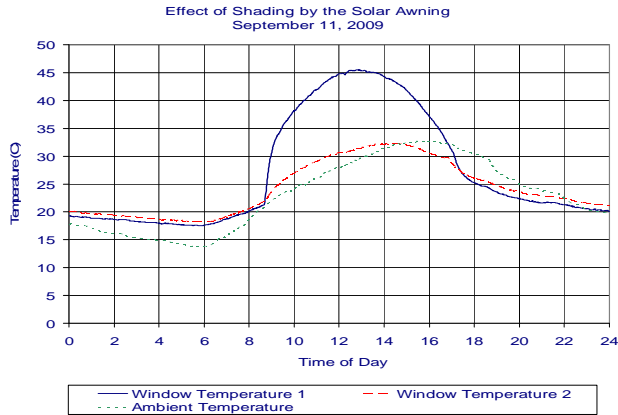
Fig. 14: Temperature of the window above and below the solar awning. Ambient temperature is also included. Air conditioning in the building affects the window temperatures as does the incident solar radiation and ambient temperature.

cooling effect of the awning blocking the direct sunlight is to examine the temperature difference between the shaded window area and the window area exposed to the direct sunlight. The temperature of the area exposed to direct sunlight is up to 15°C higher than that of the area in the shade (Fig. 14).

affects the temperature of the single pane window, but this is moderated by the temperature inside the building. Since this is one pane of glass, the conduction of heat from above the light shelf does have some affect on the pane temperature below the light shelf. However, the 15 °C temperature difference between the two areas shows significant cooling effect of being in the shade.
